Images in cardiology

# Quantitative assessment of right ventricular structure and flow dynamics in pulmonary homograft obstruction

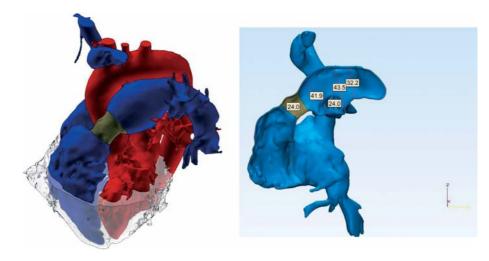
**Figure 1.** 3D anatomical model reconstructed from gadolinium-enhanced MR images (red: systemic circulation, blue: pulmonary circulation with the homograft shown in dark gray, light gray: myocardium). Measurements in the right panel are in mm.

The 3D model showed slightly enlarged right ventricular (RV) cavity with good contractility. Importantly there was no evidence of RV hypertrophy, with the thickness of the free wall of the RV measuring 2 mm. The allograft valve (shown in dark grey in Figure 1) measured 2.4 cm in diameter, which was identical to the original size at insertion. The main and left pulmonary arteries were markedly dilated, measuring 4.19 cm and 4.35 cm respectively (Figure 1).

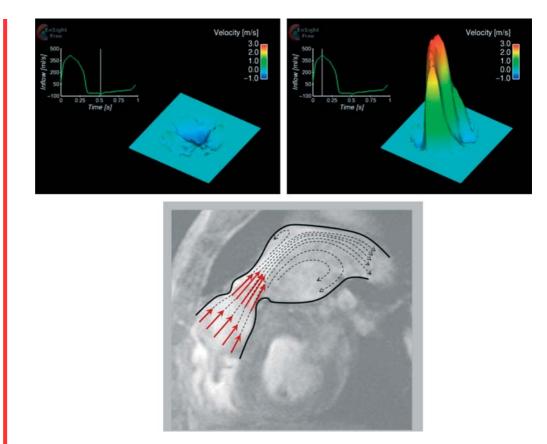
**Figure 3.** Through-plane velocity map immediately downstream to the pulmonary valve, based on phase-contrast MR images (top: diastole, middle: systole). The waveform superimposed in the figures were reconstructed from cine series of phase-contrast images. The velocity here represents combination of three spatial velocity components (head-foot, right-left and anterior- posterior) and hence the velocity magnitude is larger than that in Figure 2, which is only head-foot component. The diagram in the bottom panel illustrates the flow patterns in systole.

The diameter of the homograft in proportion to the dilated MPA was 57% and also due to relatively small orifice area equivalent to a moderate stenosis in case of the aorta (Bonow et al.<sup>3</sup>), the flow through the homograft became a high-speed jet. The jet flowing into the dilated MPA is accompanied by flow separation and recirculation (Figure 3) which are likely cause of disturbance in the flow, resulting in a significant energy loss that was estimated 26.6 mmHg. This means that the RV of this patient is required to provide extra 26.6 mmHg of pressure to overcome energy loss and ensure perfusion of the blood to the lungs.
